Cutting Tools Files and a Microscope.

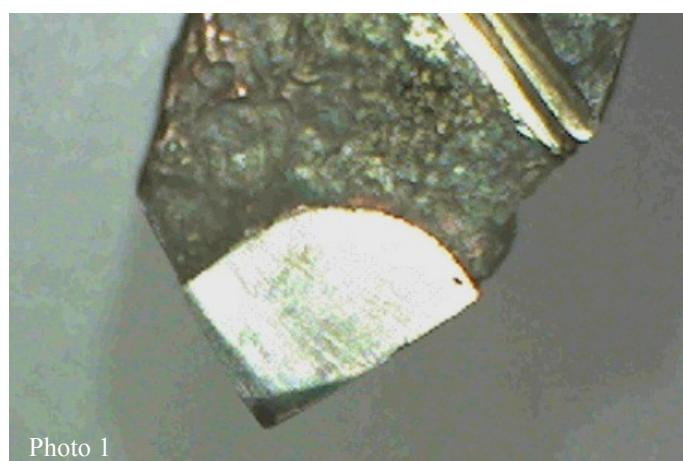
Photo 1

My application was photographing small engineering components. The first photograph is of a worn brazed carbide tip lathe tool taken at 10 times magnification. Image resolution is 640 x 480 pixels, but if the software would behave, it should be possible to increase the resolution to 800 x 1200 pixels. I have cropped the image to the relevant part.

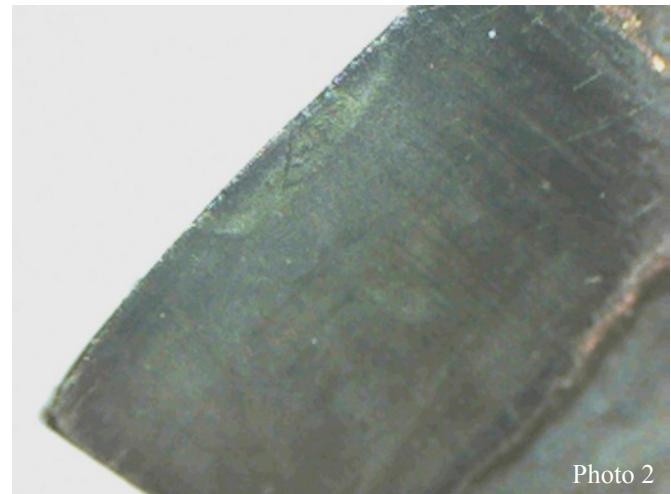
Photo 2

Lighting for the microscope is by LEDs, and the computer adjusts the image. Consequently the colour bears little resemblance to the appearance of the tip in natural light. The microscope has three magnification settings. At 60 times magnification, fracture on the face of the tip is clearly visible.

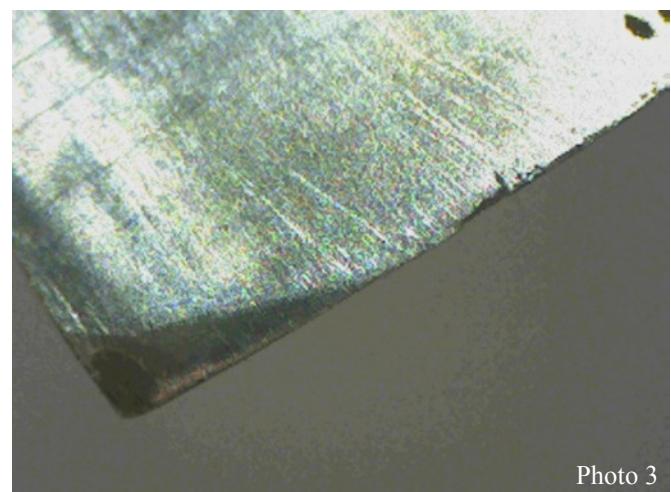
Photo 3

At the highest magnification of 200 times, the top of the cutting tool looks very sad indeed.

Notice that the tip wear shows darker. This is not due to any discolouration of the tool tip, but results from the lighting conditions. The cutting tool is a 3 dimensional surface and the worn edge is reflecting the incident light in directions other than the microscope lens. Consequently it appears darker.

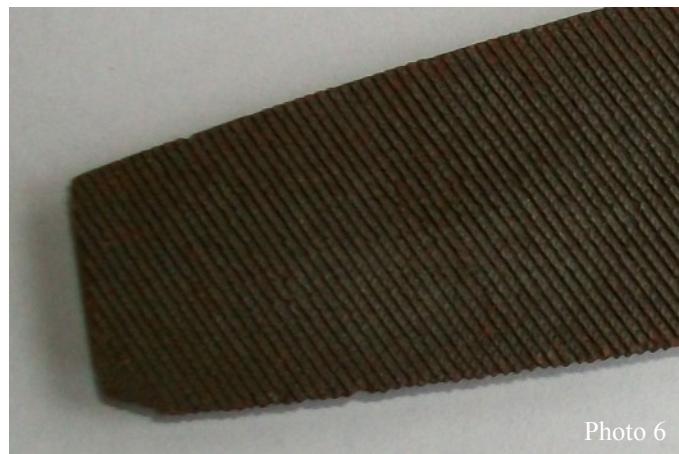
Photo 6

I have included a general view of the tip of the file I used for my etching experiment after it had been cleaned with the copper scraper and prior to dipping.

Although the file had been cleaned up considerably, examination under the microscope at 10 times magnification, showed that there was a lot of residual debris in the crevices.

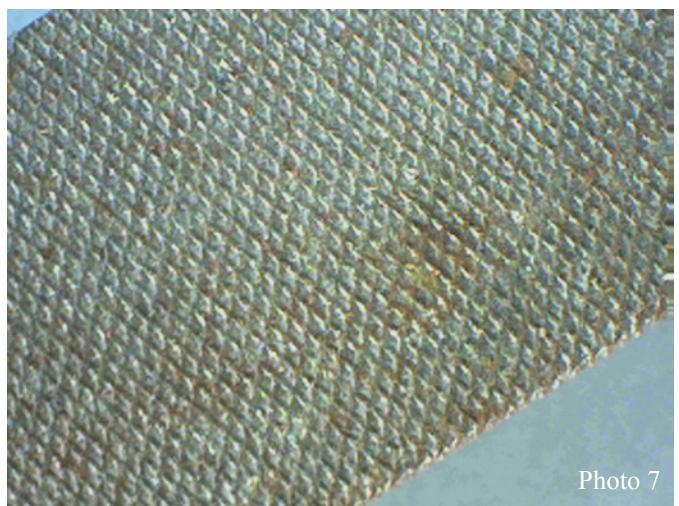
Photo 7

Magnification of 60 times shows the debris clearly. The cross cut pattern of the file is not as I had imagined it would be from textbook descriptions. The cuts running from left to right in the image are much deeper than those running from top to bottom. The image at 10 times magnification gave the impression that the cuts were of similar character, but the higher magnification reveals that this is not the case.

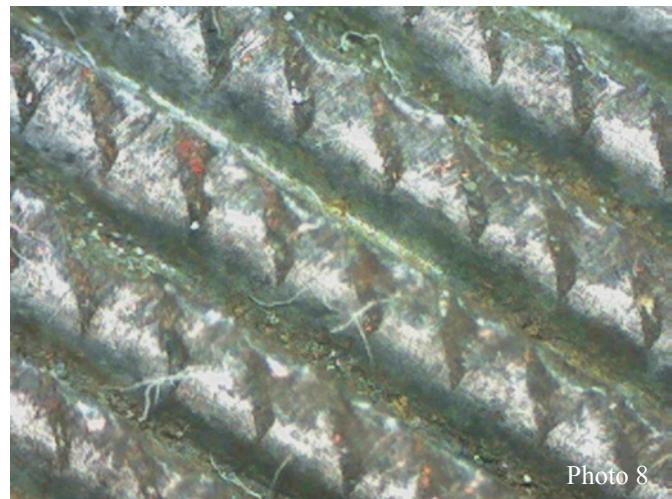
Photo 8

The pieces of fibre are likely to have come from the cloth used to wipe the file after cleaning. I suspect that the red coloured traces are pieces of copper from the scraper.

At this magnification, the depth of focus is not quite sufficient to provide a clear image of the tooth profile.

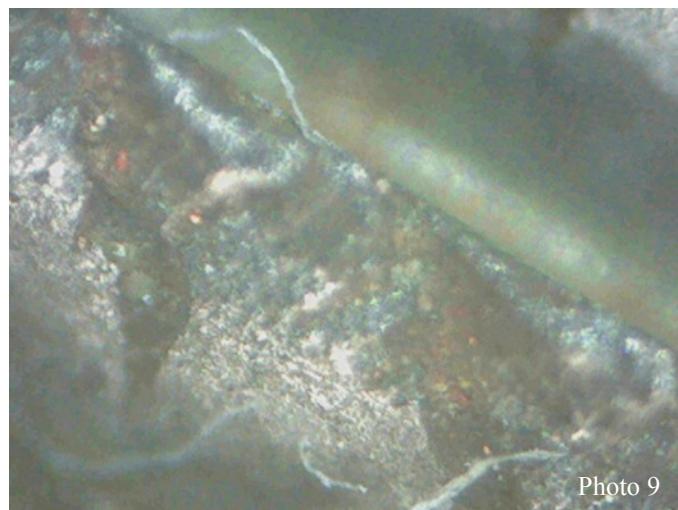
At the maximum magnification, it was not possible to get a really clear image. Contrast was markedly reduced. However, I was surprised that the loss of depth of field, already apparent at 60 times magnification, had not become so severe that it spoiled the image completely. It is possible that the image processing attempts to de-blurr the photograph and that loss of contrast is a by product of the de-blurring algorithm. I would be more comfortable if I knew exactly what the software was doing.

Although at the highest magnification there is no evidence of cutting teeth, the place where there might have been a single tooth when the file was new now presents a very ragged surface to the material being worked. The original channels criss crossed the teeth and still provide recesses into which the metal filings can flow.

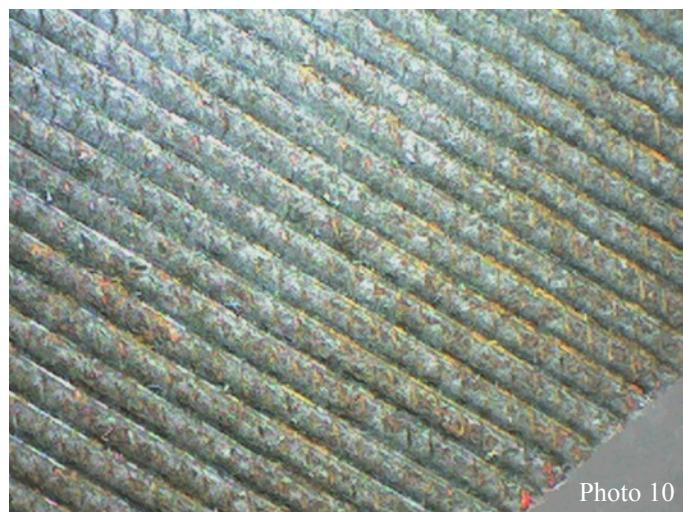
The reaction was not vigorous and the main evidence that something had happened was the presence of a black granular sediment in the acid and discolouration of the file. After washing the file, there was a distinct difference between the feel of the part of the file which had not been etched and that part which had been immersed in the acid. The latter was definitely rougher to the touch. The photograph of the etched surface at 10 times magnification shows a distinctly matt appearance and the cross cutting is much less marked.

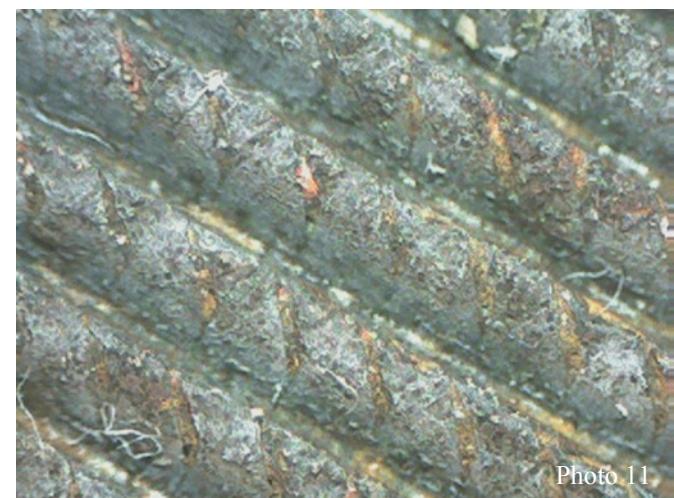
At 60 times magnification, it seems that any tooth form has been virtually destroyed. The polished surfaces visible in the photographs taken prior to etching have been similarly etched and this may be responsible for the sensation of increased roughness noted above.

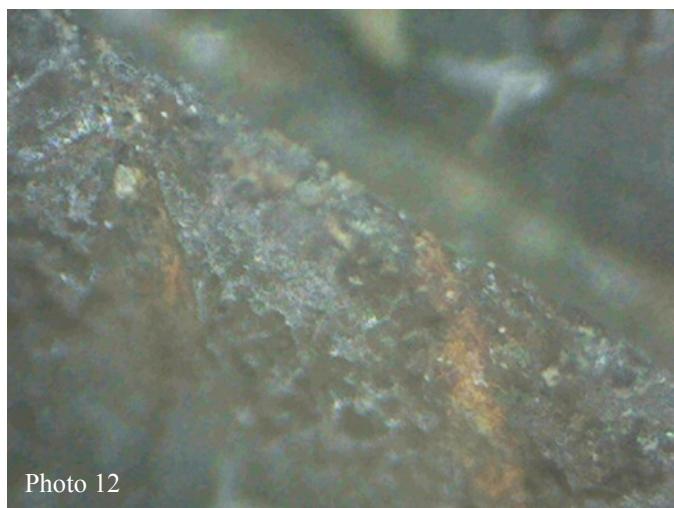
Photo 12

At maximum magnification it can be seen that the tooth form has indeed been all but destroyed. However the extensive pitting may well be represent a more effective cutting surface, particularly since the height of the roughness is more uniform than the worn teeth.

The dullness of the images taken after etching is probably a consequence of the loss of reflectiveness which had been present prior to etching. This would reduce the natural contrast, it is anybody's guess how

The orange coloured specks are possibly the remaining traces of copper from the scraper still lodged in the teeth. It is worth noting that the presence of the copper might have given rise to preferential etching through a dissimilar metal effect. Copper is lower in the electrochemical series than iron and should promote preferential corrosion of the iron.

In the event that seems to be what happens. In the light of this brief examination I would certainly not acid etch any new file. However, the finer and more even roughness produced by the etching may well be a useful treatment if an old rough file is to be assigned to finishing work.
